# Ventilator-Disconnect and Death: A Case Study and a Safety Device

**Deaths and injuries related to accidental ventilator disconnection occur in complex ways. A death related to accidental ventilator disconnection is presented from a subacute ventilator facility, and corrective action is discussed. Single-limb ventilators are now equipped with a flow-bypass coupling that prevents patient-side occlusion during disconnect and therefore prevents low-pressure alarm malfunction. Physicians and respiratory therapists can consider this device to prevent partial or total occlusion of the ventilator tracheostomy adapter, thus allowing a low-pressure alarm in the event of a disconnect.** *Key words: ventilator; mortality; patient safety; mechanical ventilation; safety.* [Respir Care 2010;55(6):774–776. © 2010 Daedalus Enterprises]

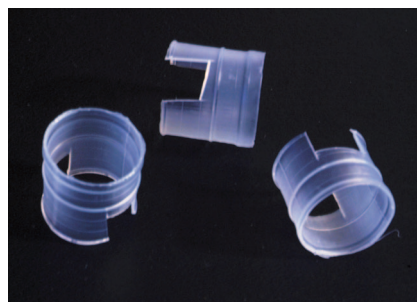
Fig. 1. Three ventilator safety couplings (at 3 angles). The notches allow flow bypass.

To make the 22-mm diameter sleeve, I began with the non-corrugated circuit plastic part, which interrupts the corrugated part in 5-cm lengths. I cut out the 5-cm non-corrugated part so I had the smooth 5-cm tubing section. Next, I cut that 5-cm tube in half, making two 2.5-cm tubes or sleeve units. The cut in the center is the base for each coupling, which slides on to the connection from the ventilator (eg, the inline suction catheter). Finally, I cut two 1-cm square notches from the top of the each 2.5-cm sleeve unit, diametrically opposite each other, being careful to avoid notching on the molding line, as this is a weak area. The cuts have to be smooth and without debris. The crown-shaped safety couplings were then ready to slip onto the tracheostomy adapter. The base of the crown goes on first, and I adjusted the notch distance beyond the tra-

This device prevents occlusion of the distal ventilator circuit following a disconnection. The notches on each side allow ventilator flow out of the circuit without creating an upstream pressure increase, thus allowing the low-pressure alarm in the event of a disconnection. It adapts to all brands of tracheostomy tubes that have a standard 15 mm outside-diameter ventilator connection. Medical-legal and safety concerns were discussed with risk managers and the institutional review board. In our first trial year of use of this device, informed consent was obtained from each patient or designated guardian prior to use.

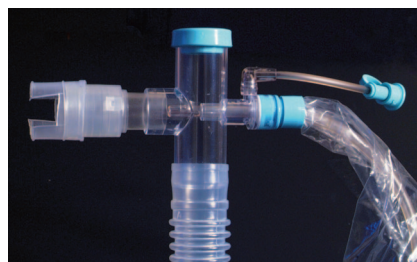
Fig. 2. Safety coupling attached to tracheostomy tube adapter.

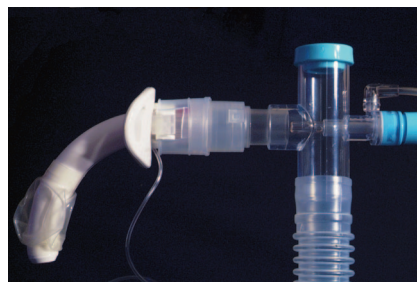
Fig. 3. Safety coupling between tracheostomy tube adapter and a Shiley tracheostomy tube. The safety coupling can also be used with a Portex or Bivona tracheostomy tube.
